**GEOLOGIC EVALUATION OF THE PROPOSED NEW TOWN SITE  
VALMEYER, ILLINOIS**

**Compiled by  
Anne L. Erdmann and Robert A. Bauer**

**Illinois State Geological Survey  
Open File Series 1993-12**

**December 30, 1993**

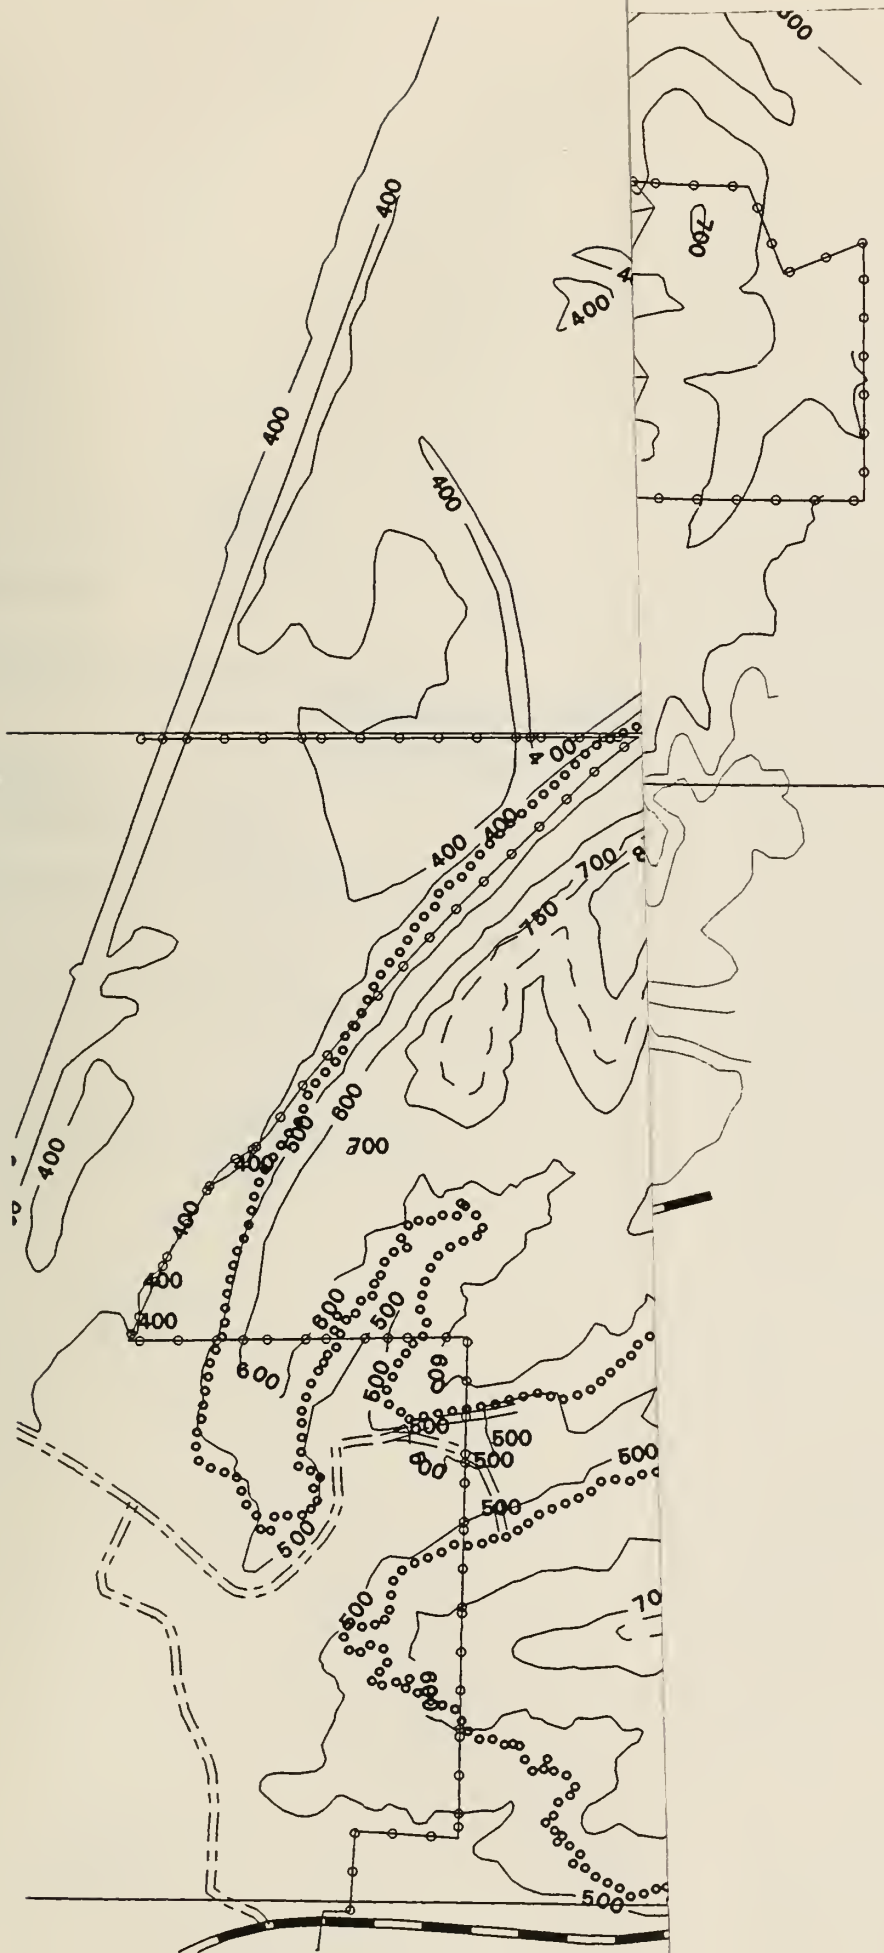
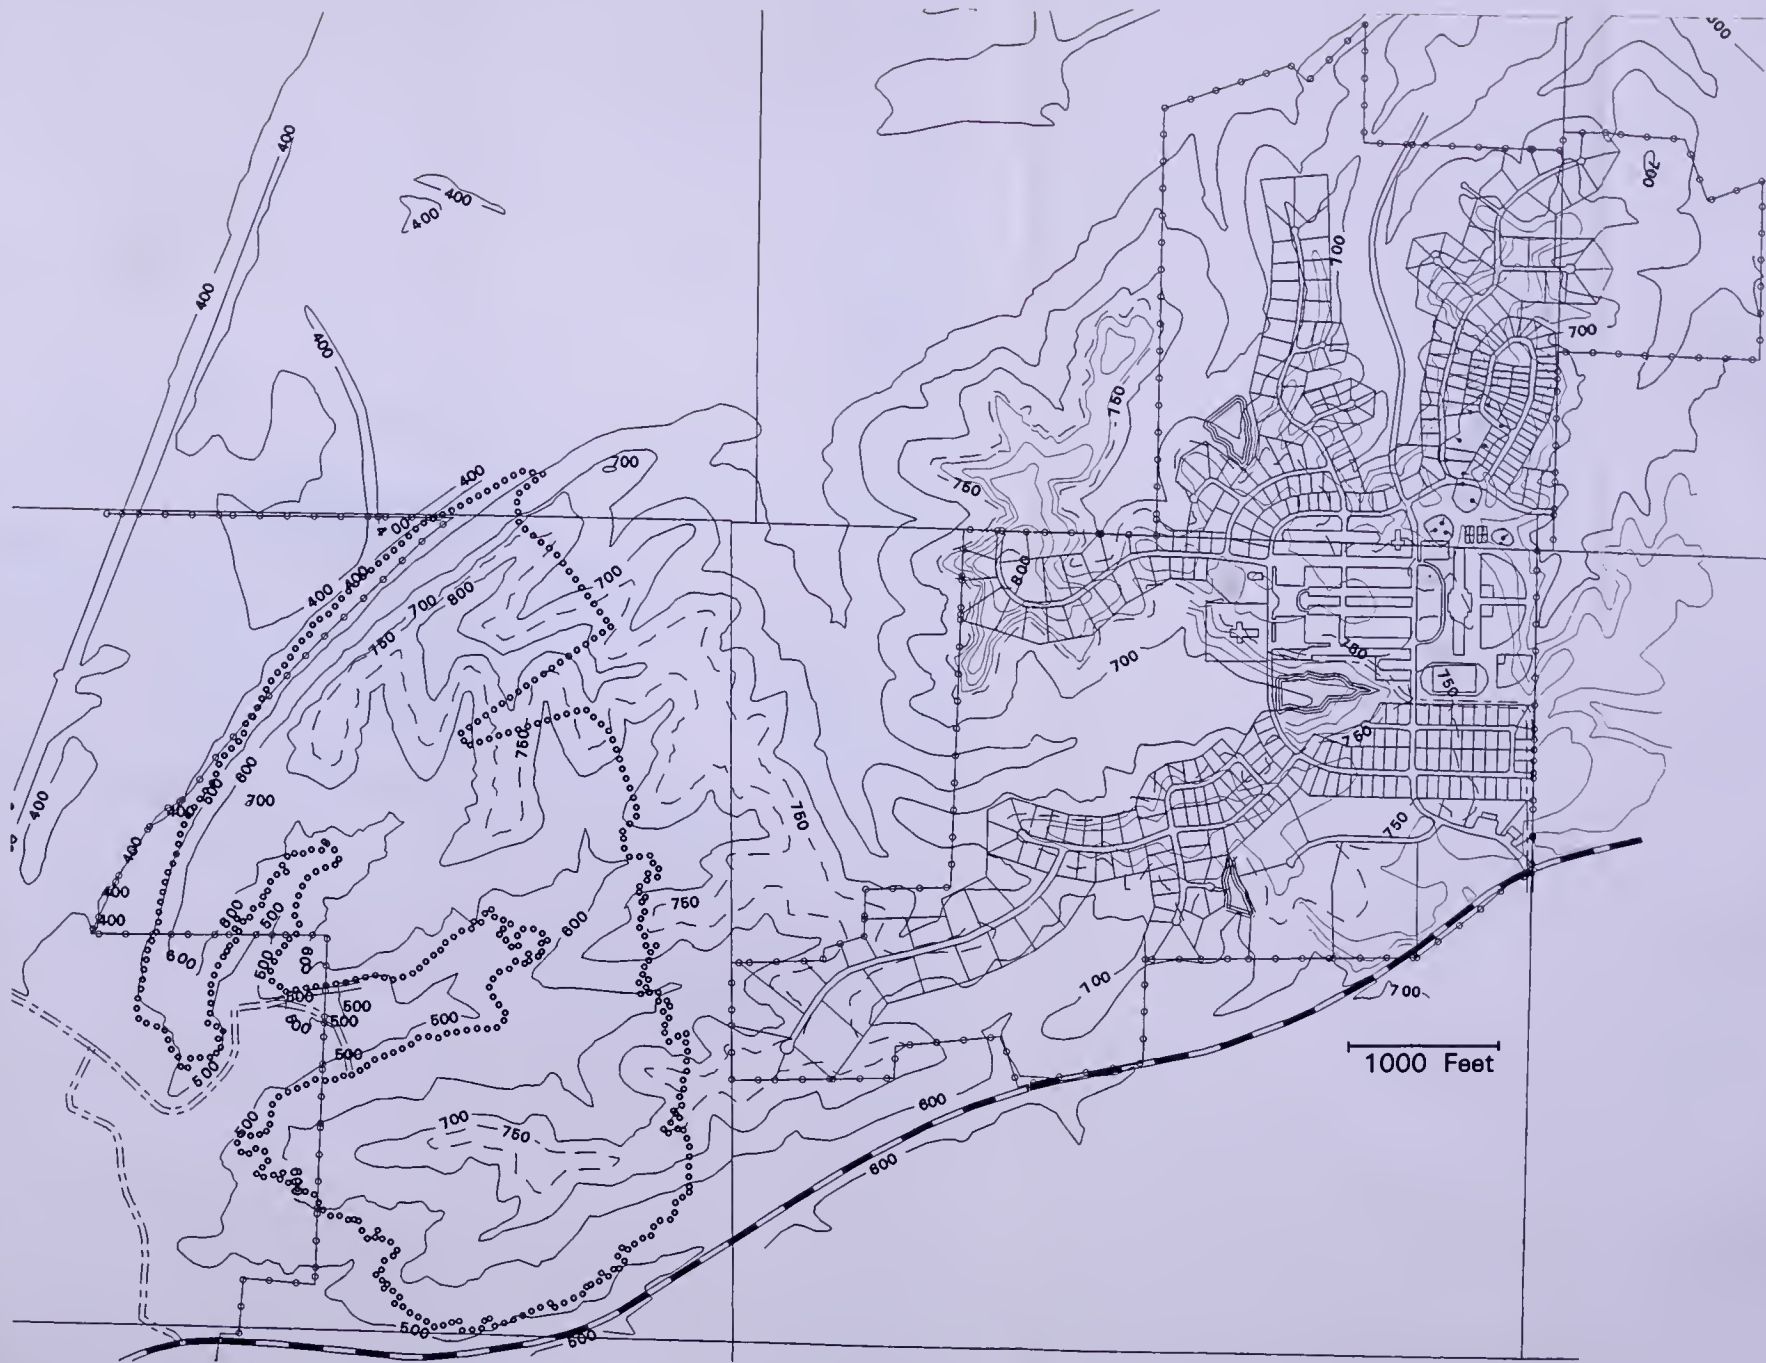
Figure 2. Map of proposed town site showing town boundary, proposed lot layout, and mapped probable sinkholes, and the approximate extent of Columbia Quarry Company mine as traced from their mine map.

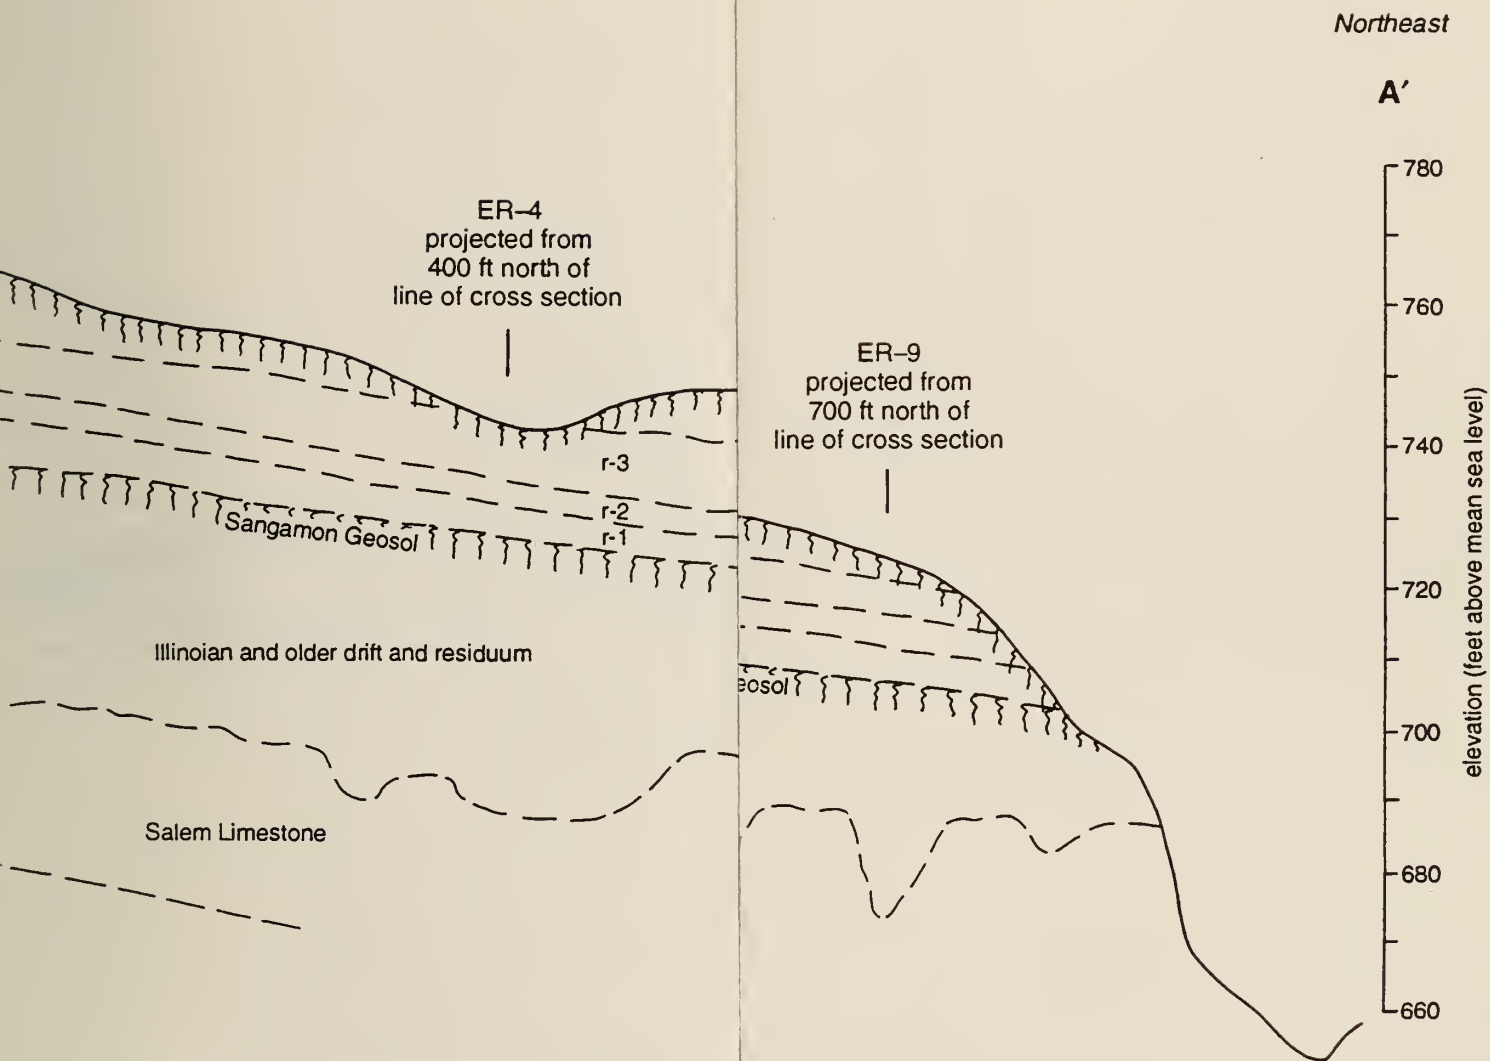
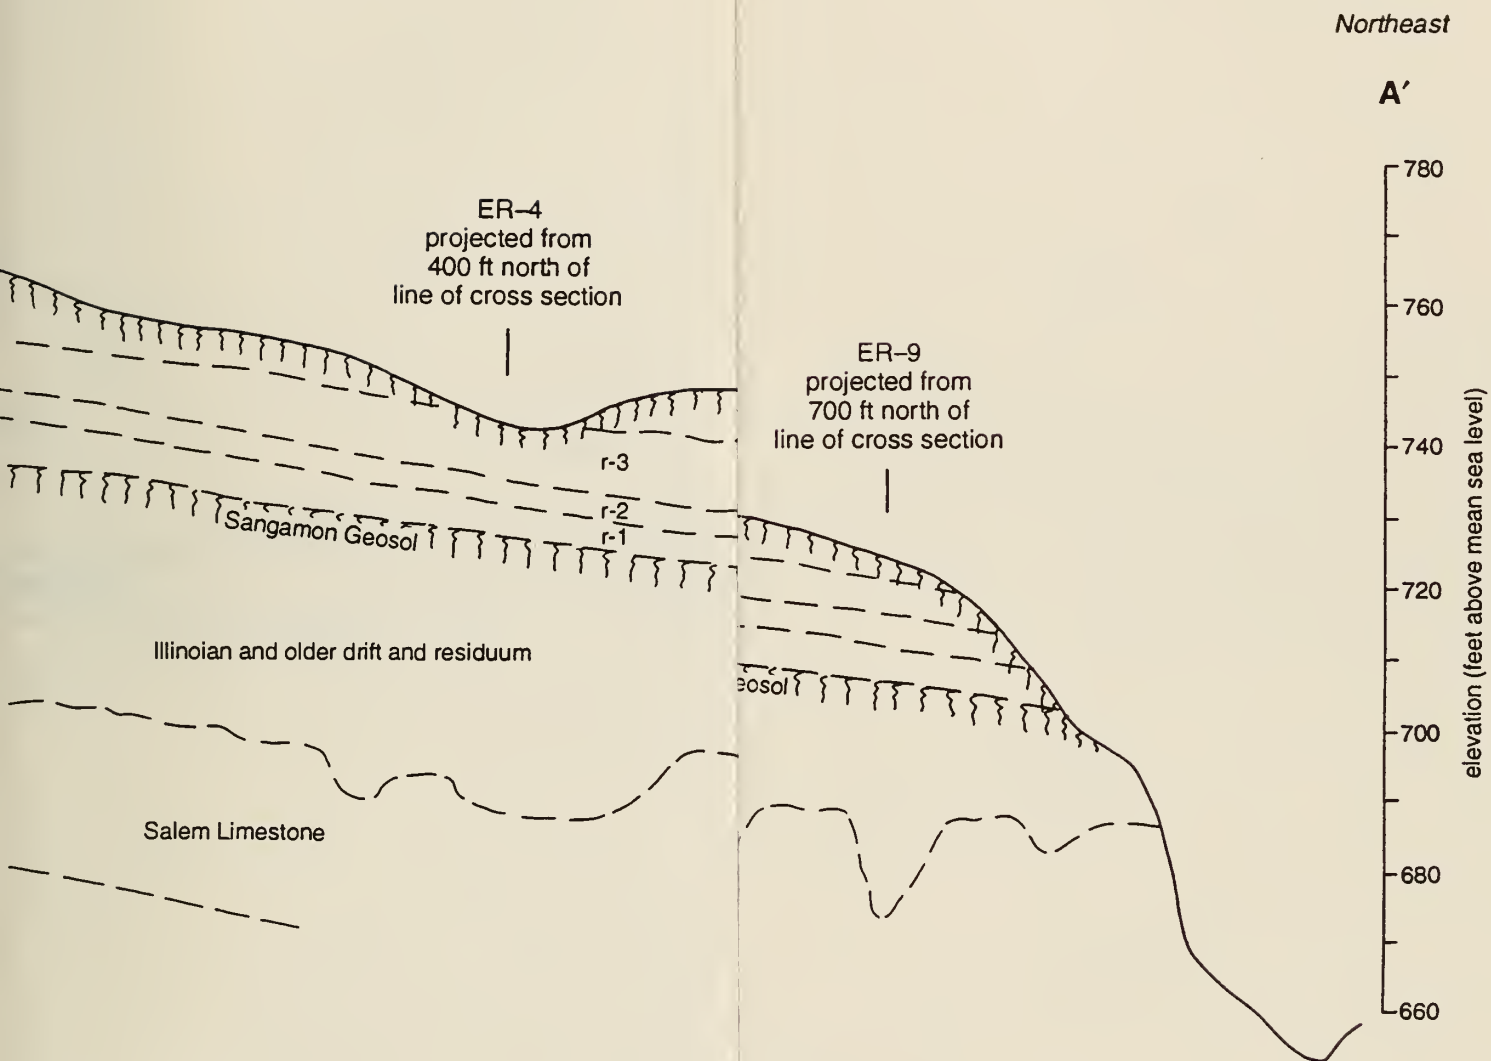
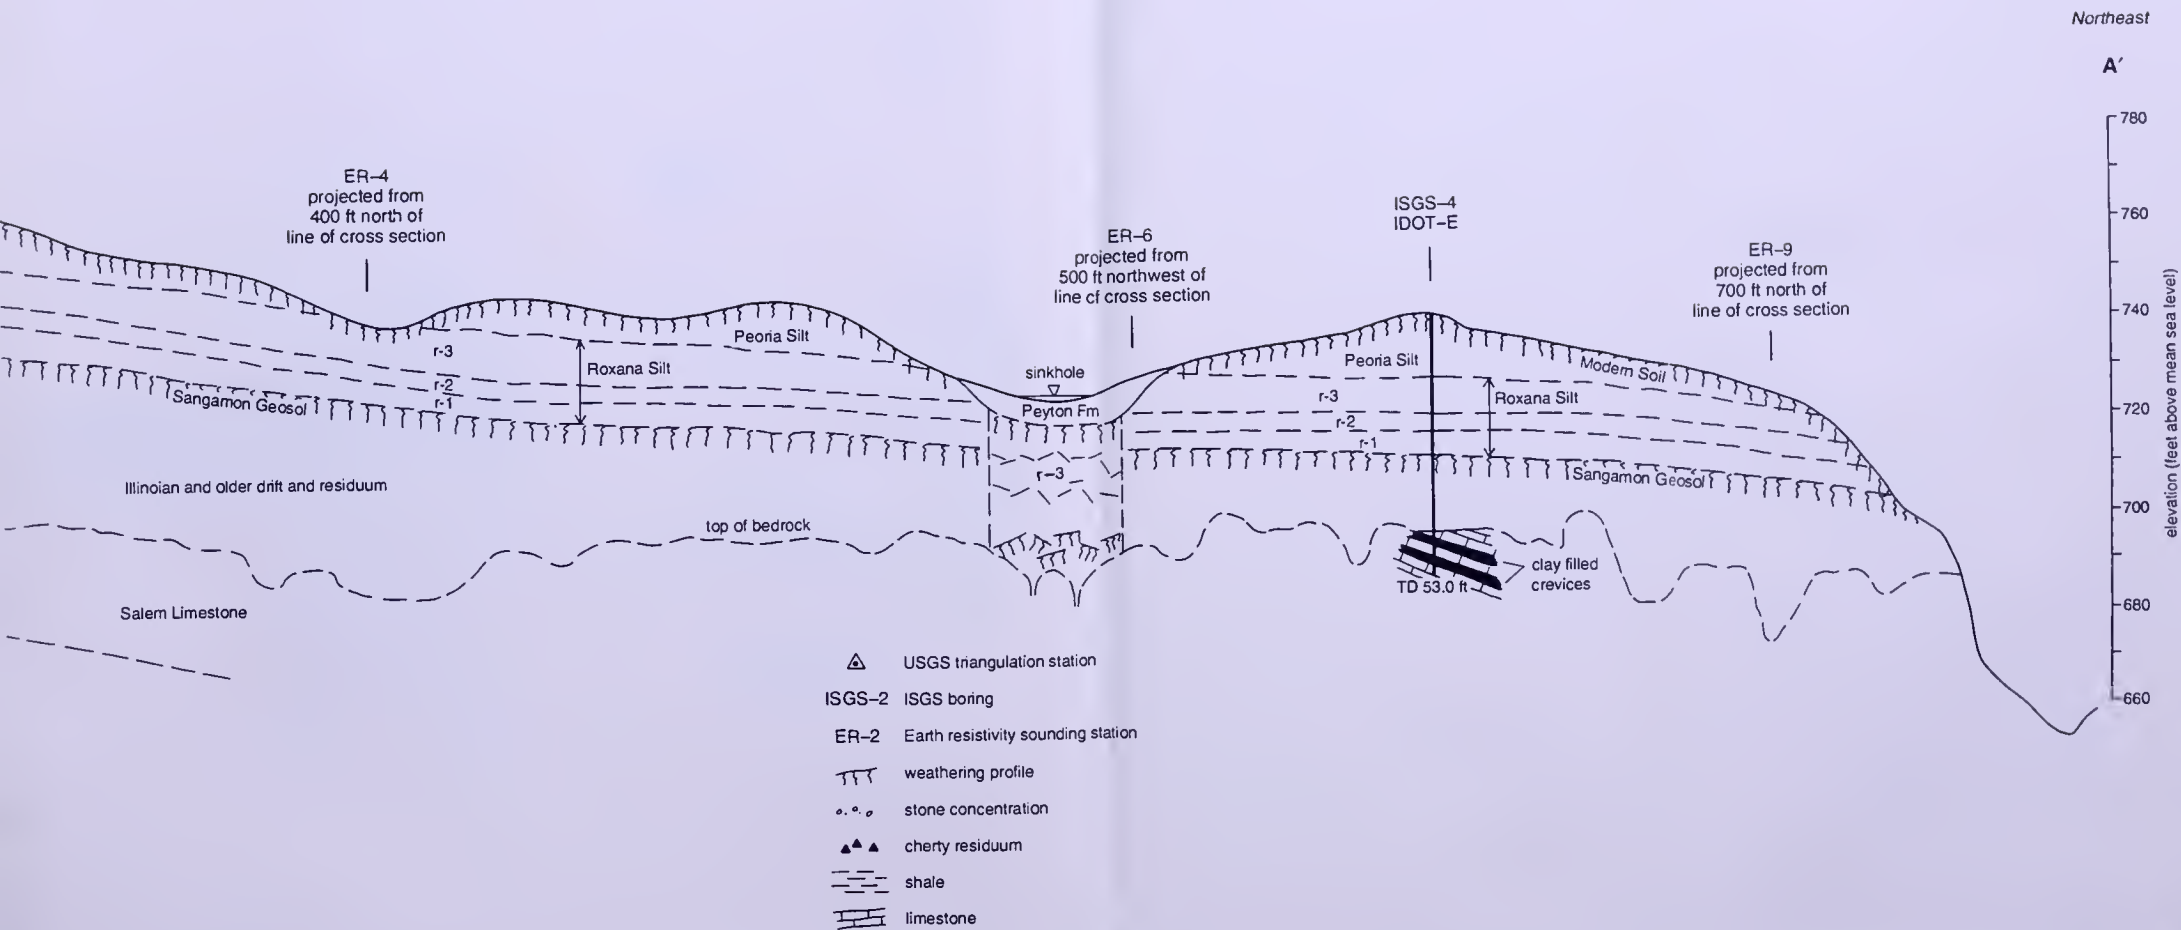
The thickness of surficial deposits, where measured by boreholes and earth resistivity, is shown on Figure 3. Beneath the highest parts of the landscape on drainage divides, the surficial deposits are typically greater than 50 feet thick. A maximum thickness of 75 feet was measured on the site. The surficial deposits are thin on steep slopes, and near the base of slopes, the deposits consist of a thin mantle of silt and limestone cobbles. In many of the deep gullies bordering the town site, bedrock units are exposed and have no surficial deposit cover.

Figure 3. Cross-section A-A' through the surficial materials at the proposed town site. Locations of boreholes drilled by ISGS and IDOT, and locations of earth resistivity sounding stations, are shown. See Figure 1 for location of cross-section line.

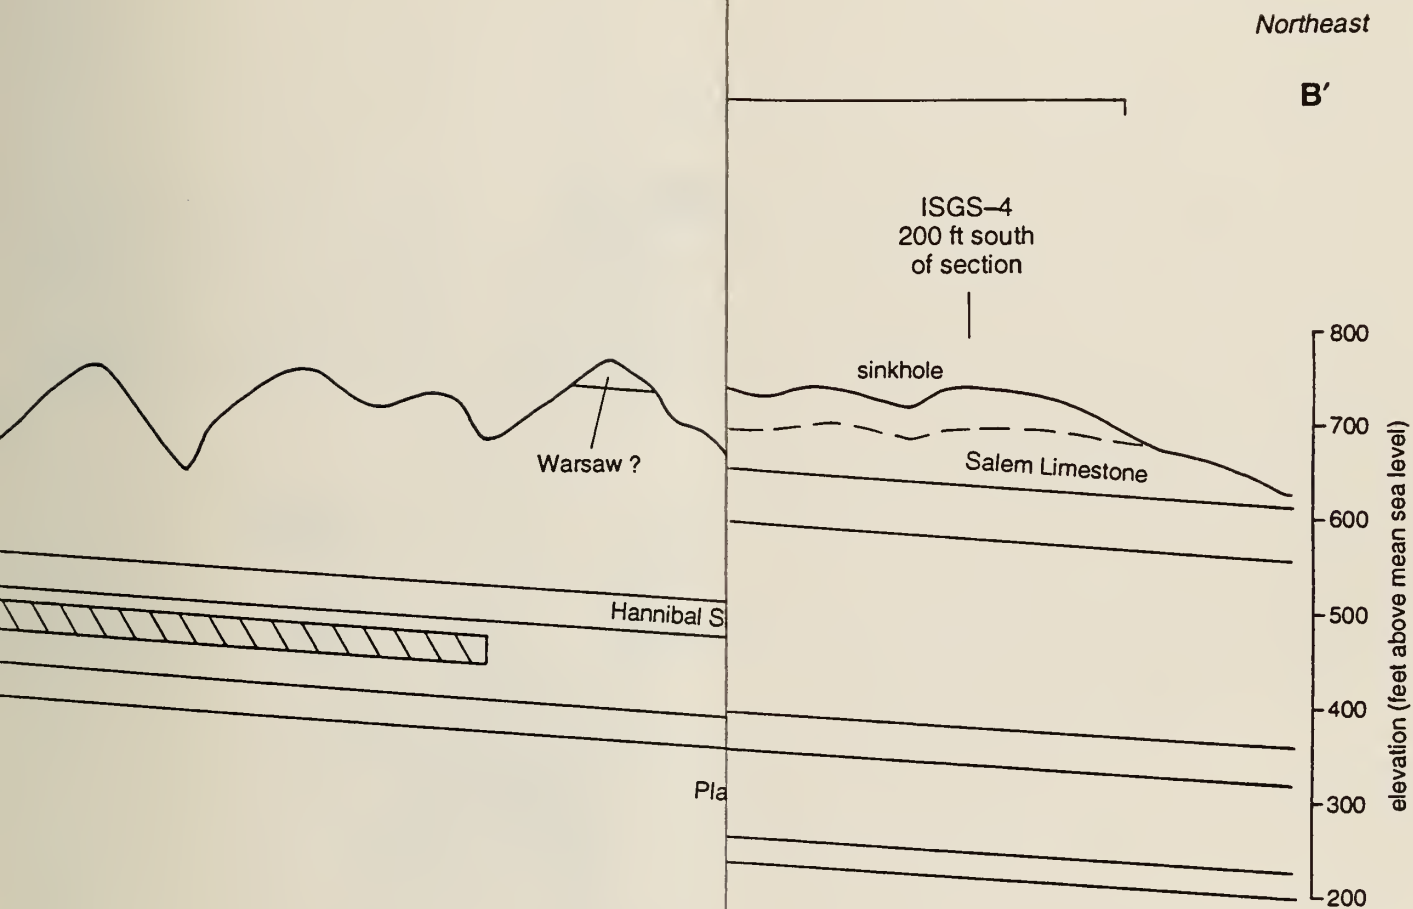
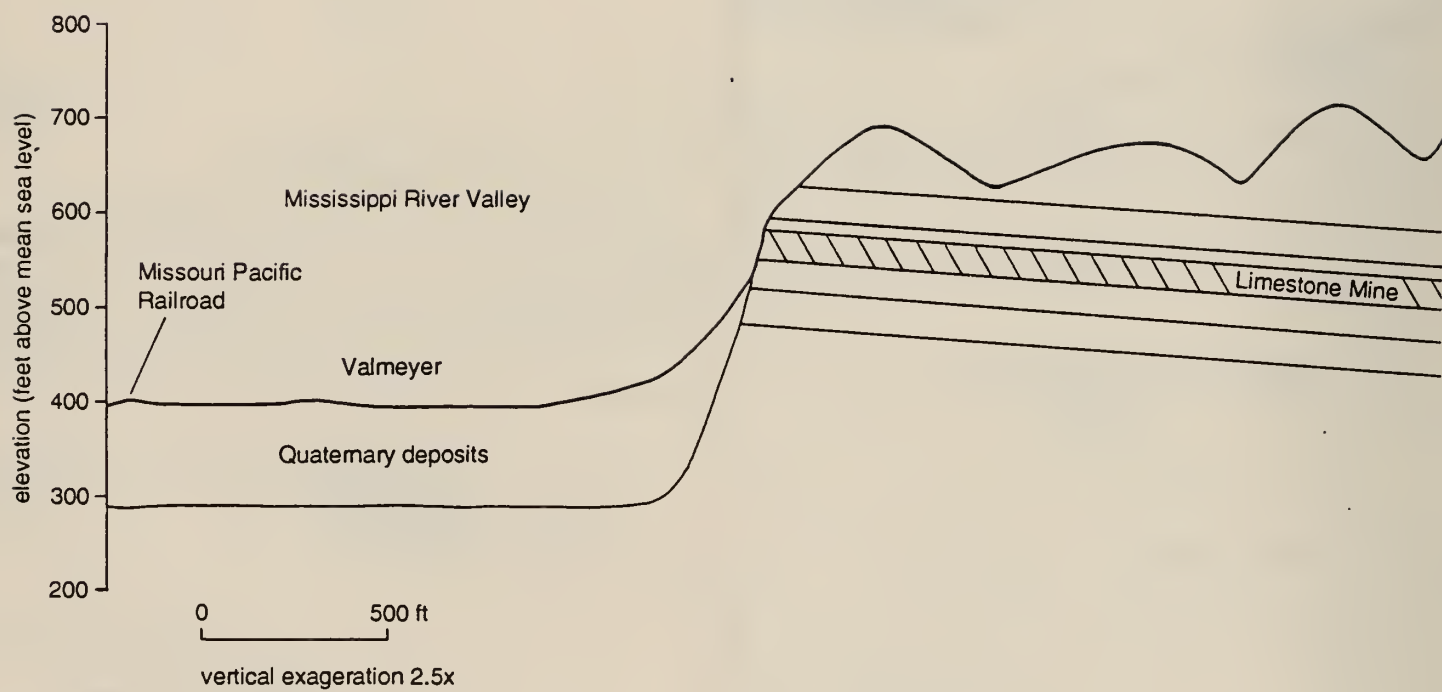
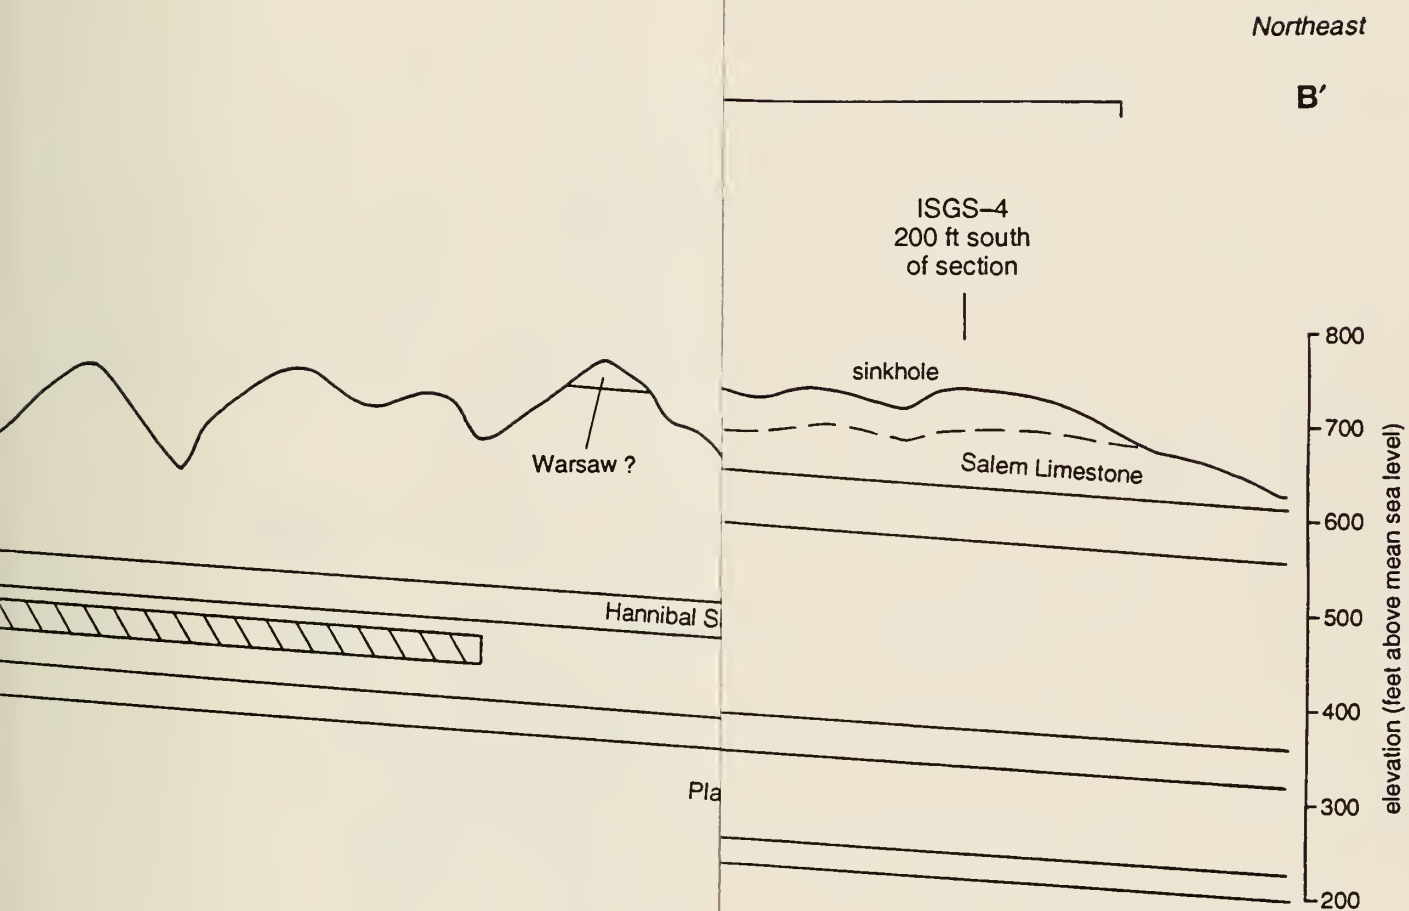
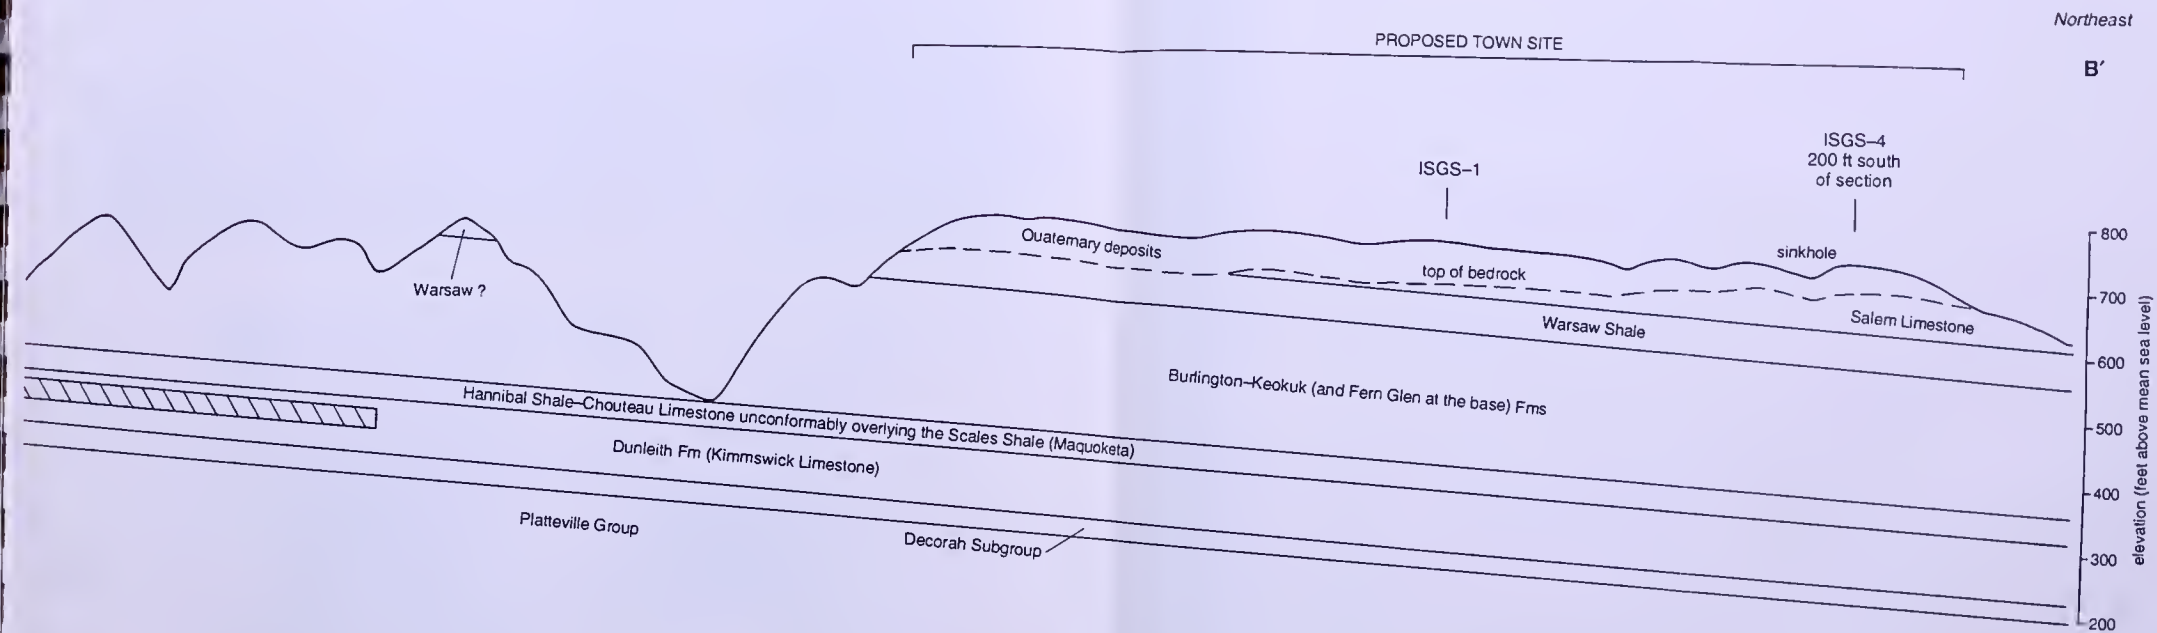
Figure 4. Cross-section B-B' through the bedrock units from old Valmeyer on the west to the proposed town site on the east. The location of the Columbia Quarry Company's limestone mine is indicated by the diagonal-line pattern. See Figure 1 for location of cross-section line.

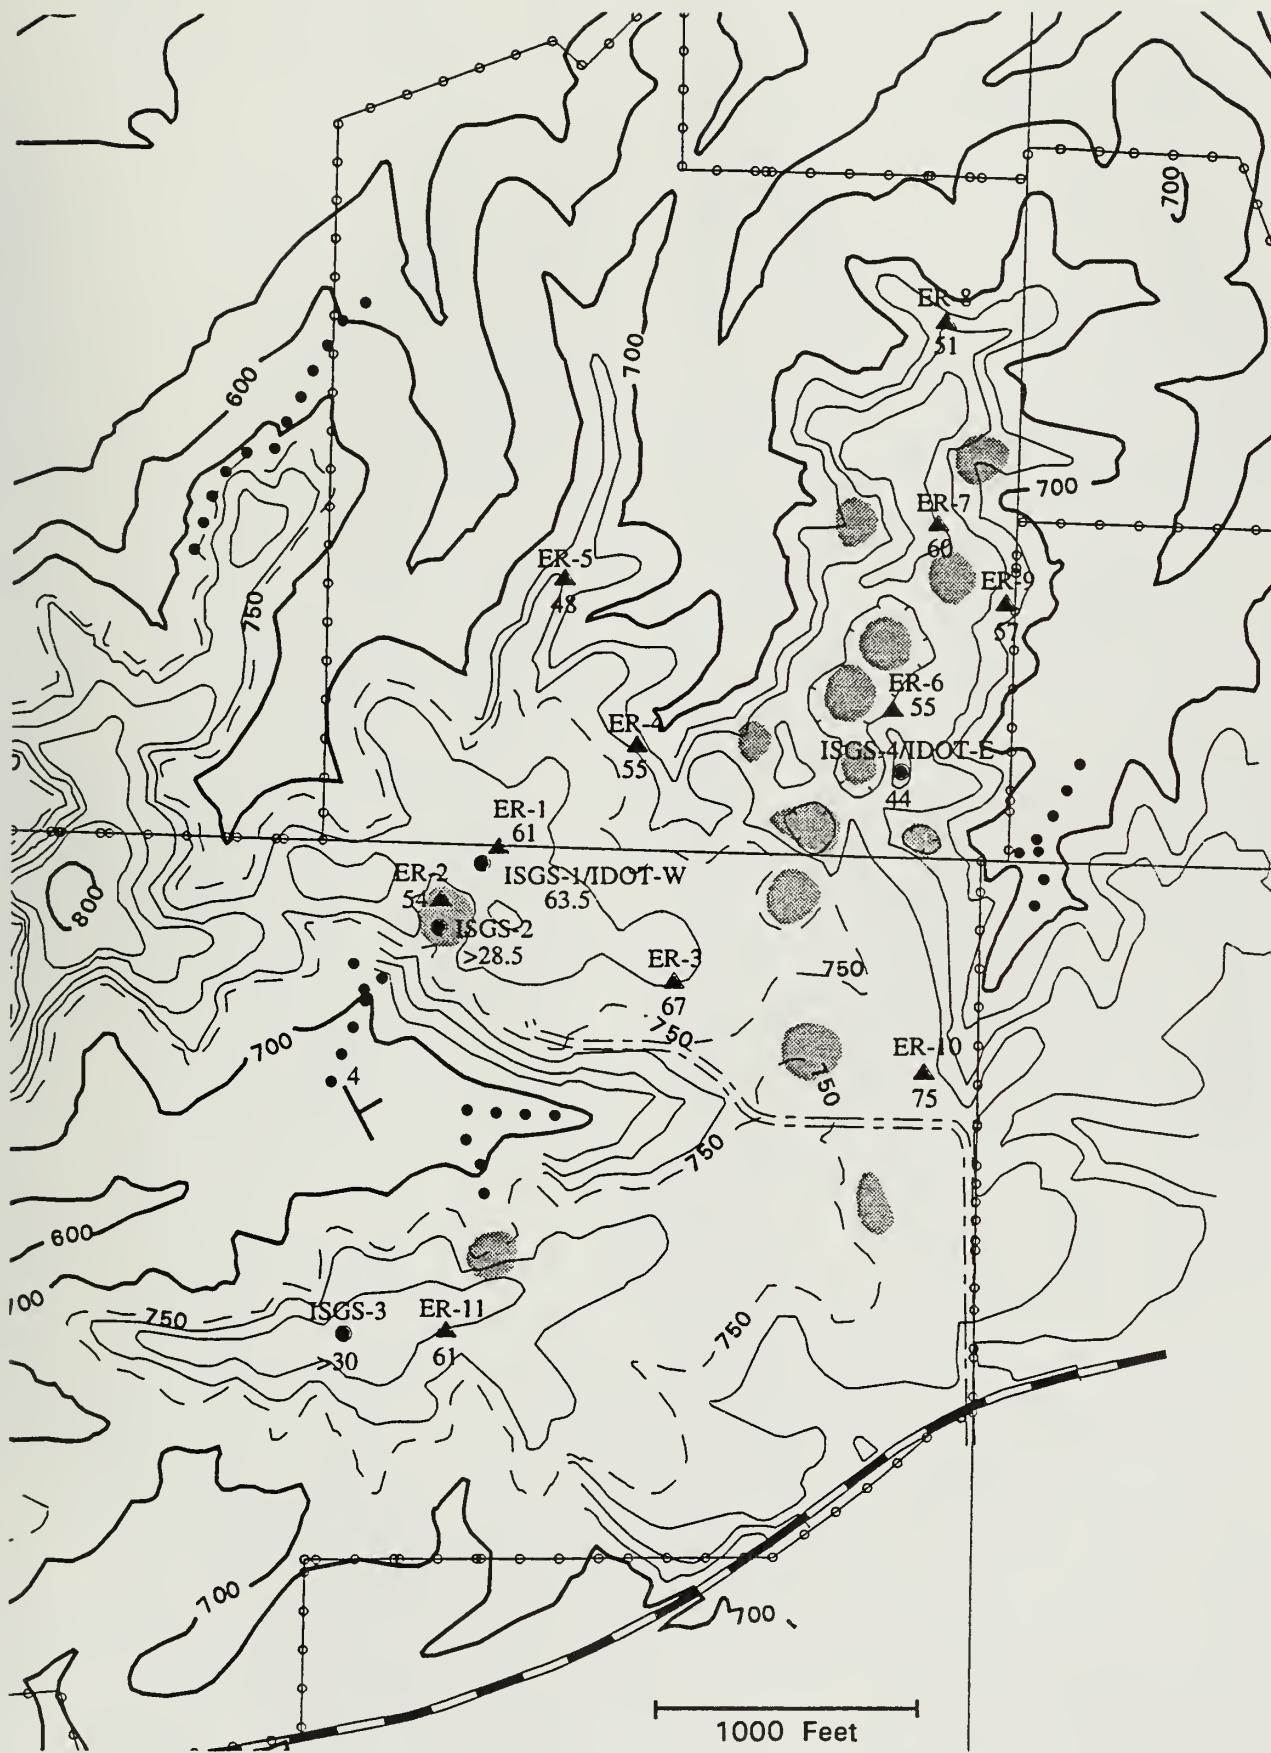
Figure 8. Map of proposed new town site showing town boundary, borehole locations, electrical resistivity sounding locations, bedrock outcrops examined, and sinkholes mapped at the site.
